Groundwater Monitoring Report
October 2019 (Q4-2019) Annual Sampling Event

Rockaway Park Former MGP Site

Rockaway Park
Queens County, New York
Order on Consent Index No. D1-0002-98-11
Site No. 2-41-029

February 2020
Project 093150-4-1416

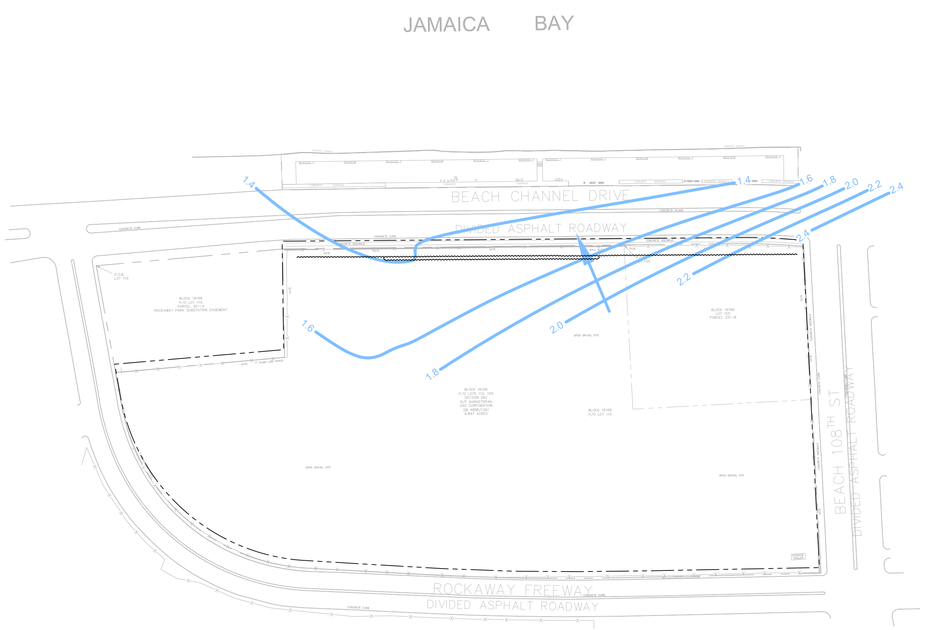
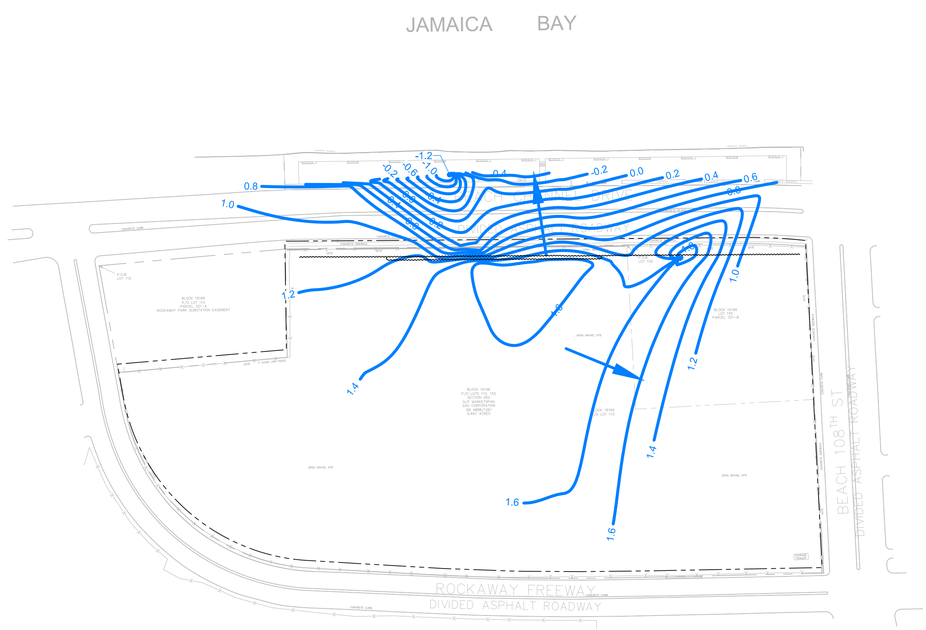
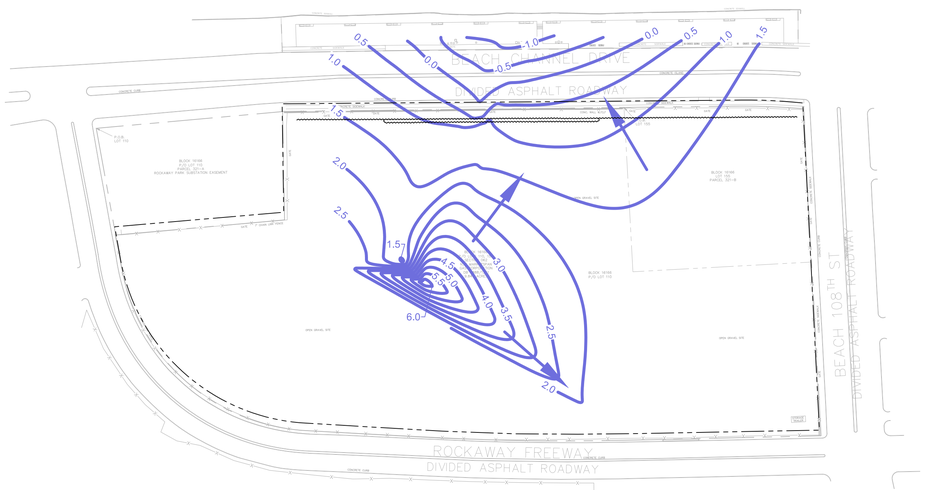
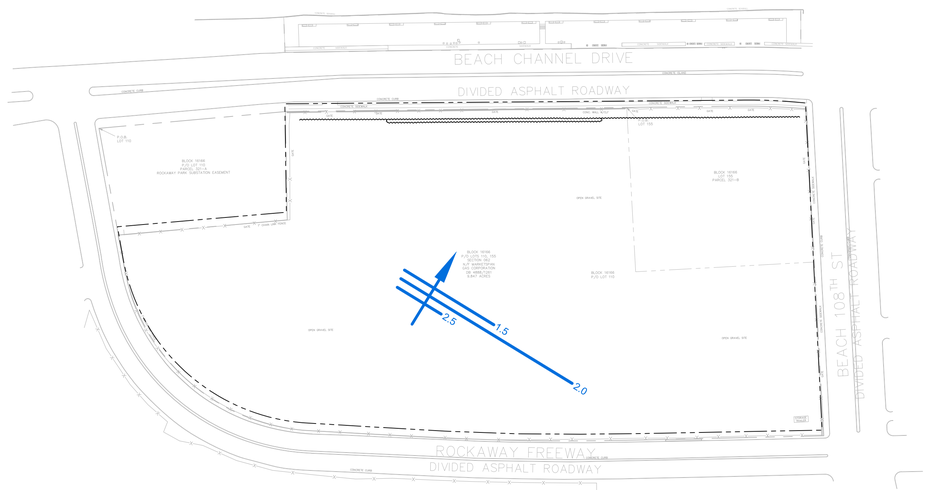
Project 093150 | February 2020 | Fig. 3

SHALLOW LOW TIDE
(SCREENED INTERVAL: 2 - 17 ft bgs)

INTERMEDIATE LOW TIDE
(SCREENED INTERVAL: 17 - 45 ft bgs)

DEEP LOW TIDE
(SCREENED INTERVAL: 45 - 90 ft bgs)

DEEP 2 LOW TIDE
(SCREENED INTERVAL: 90 - 105 ft bgs)

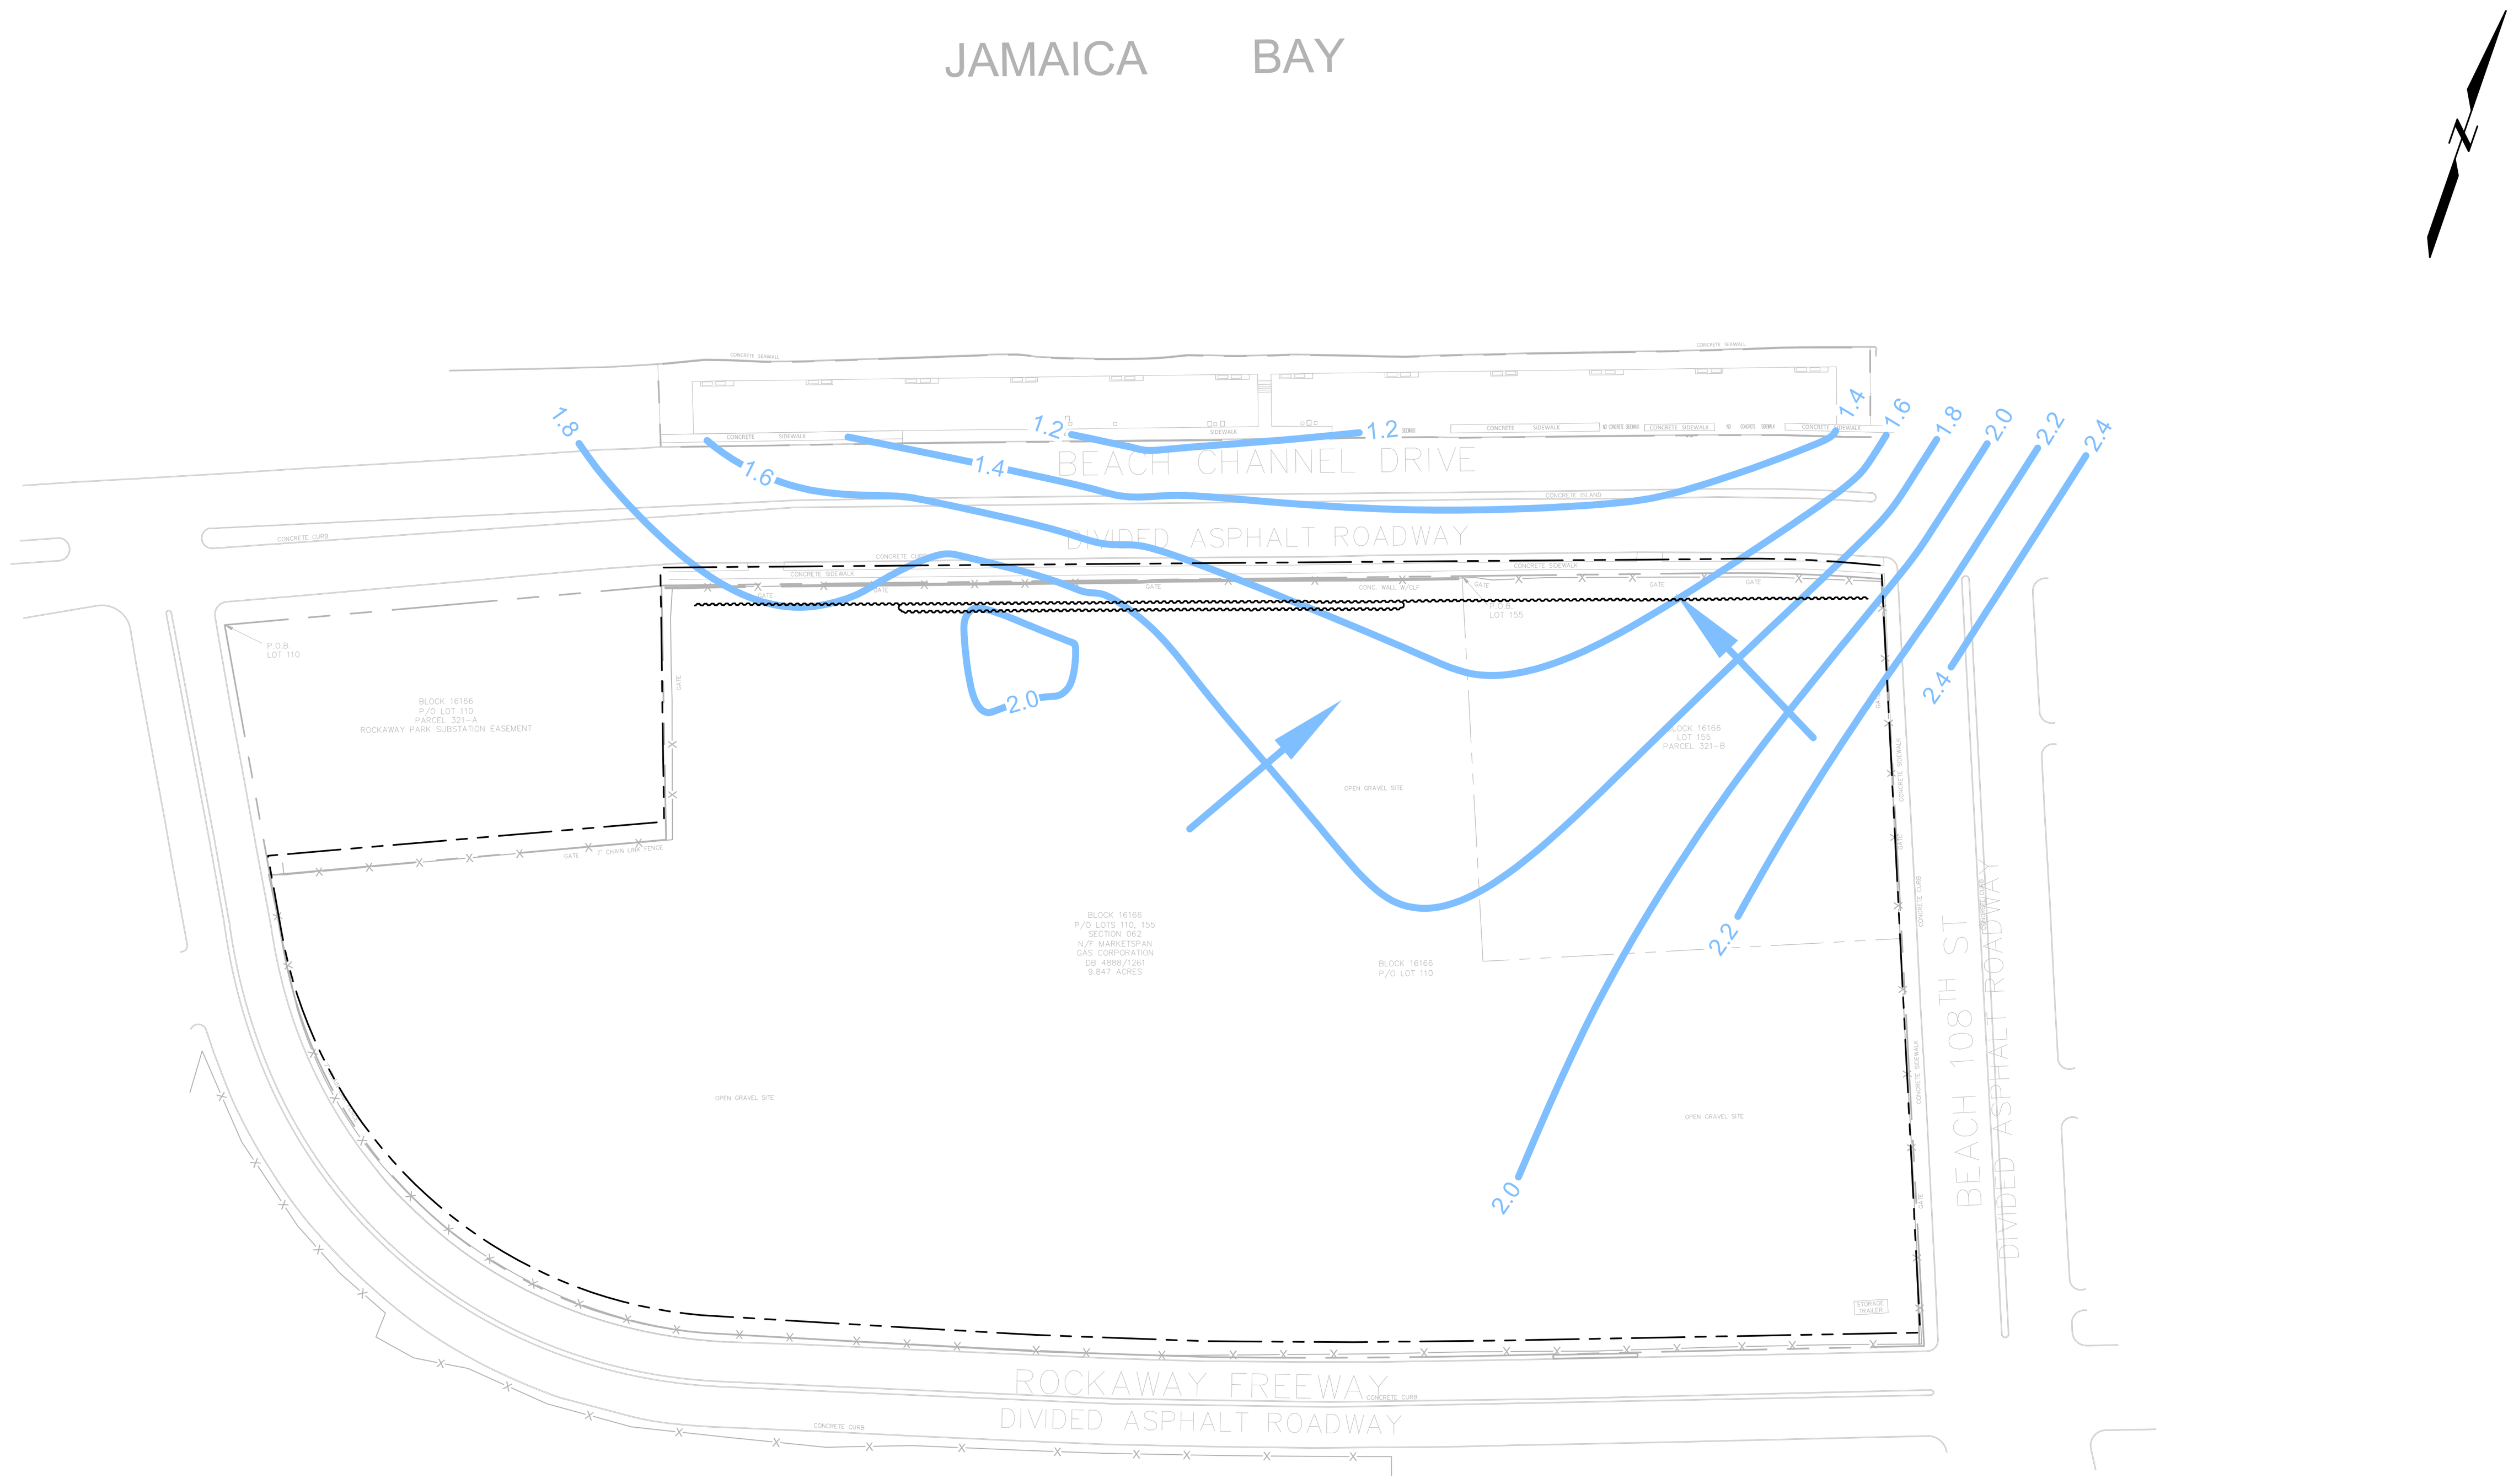
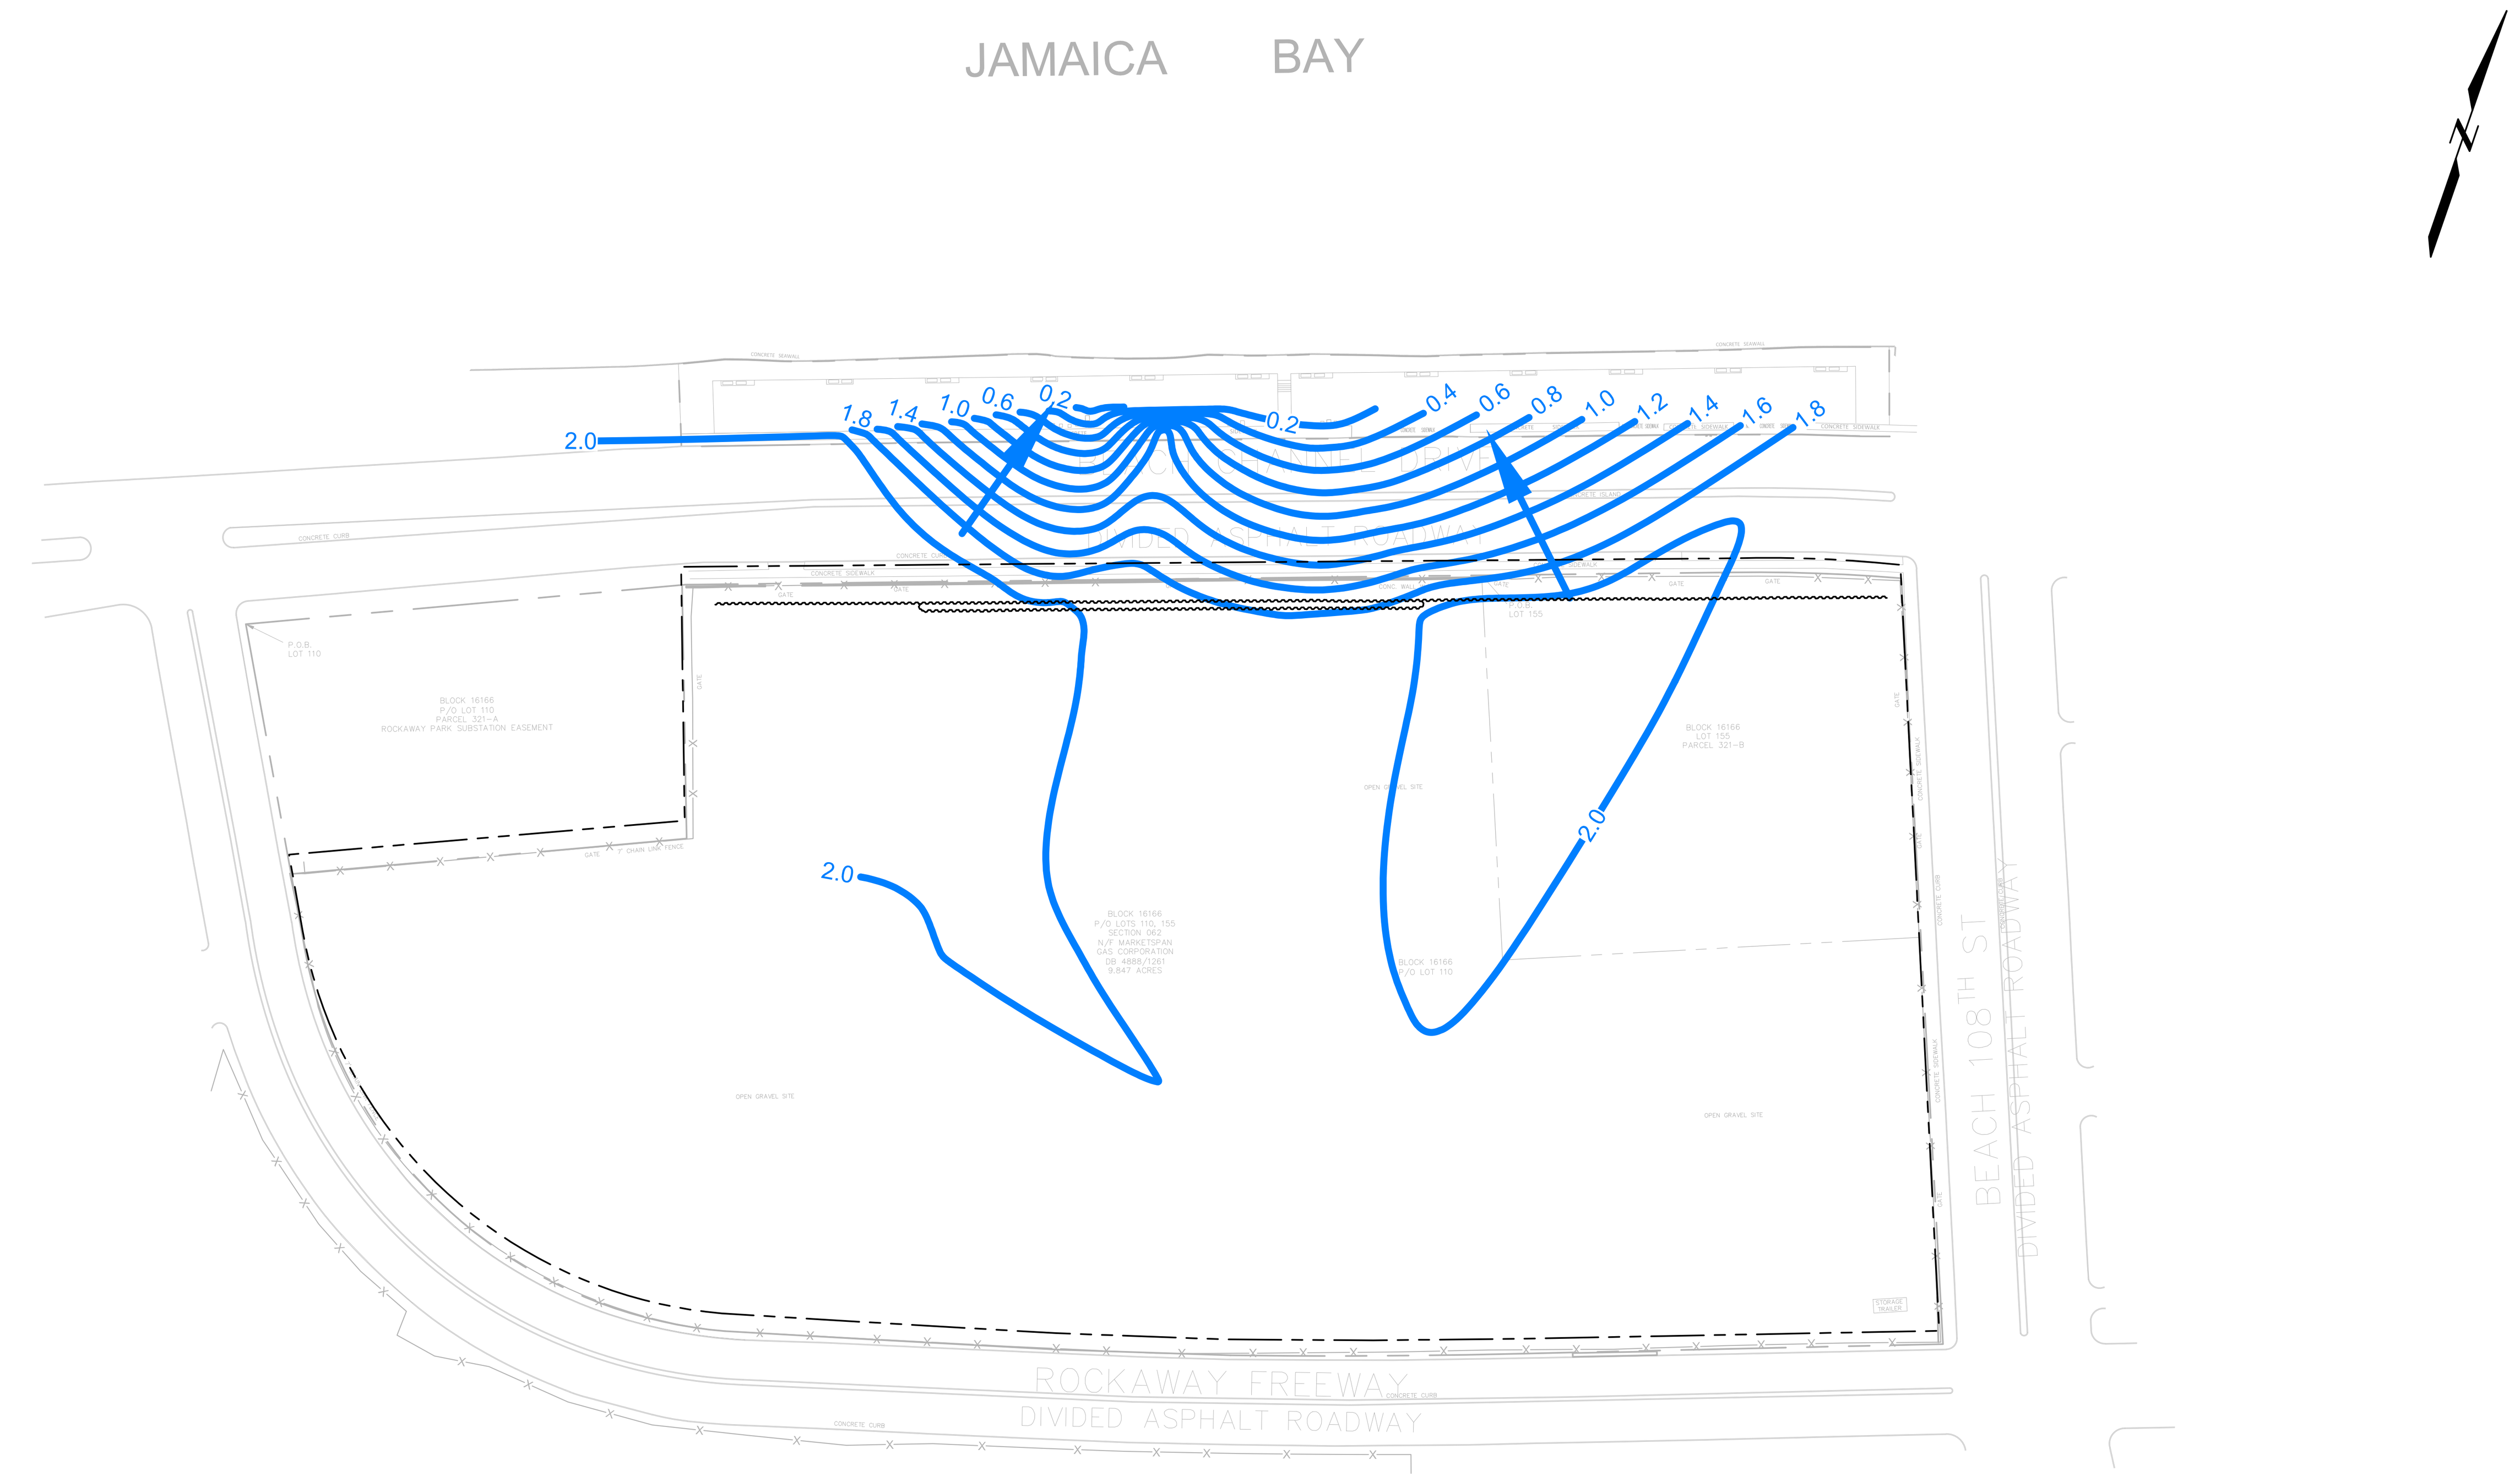
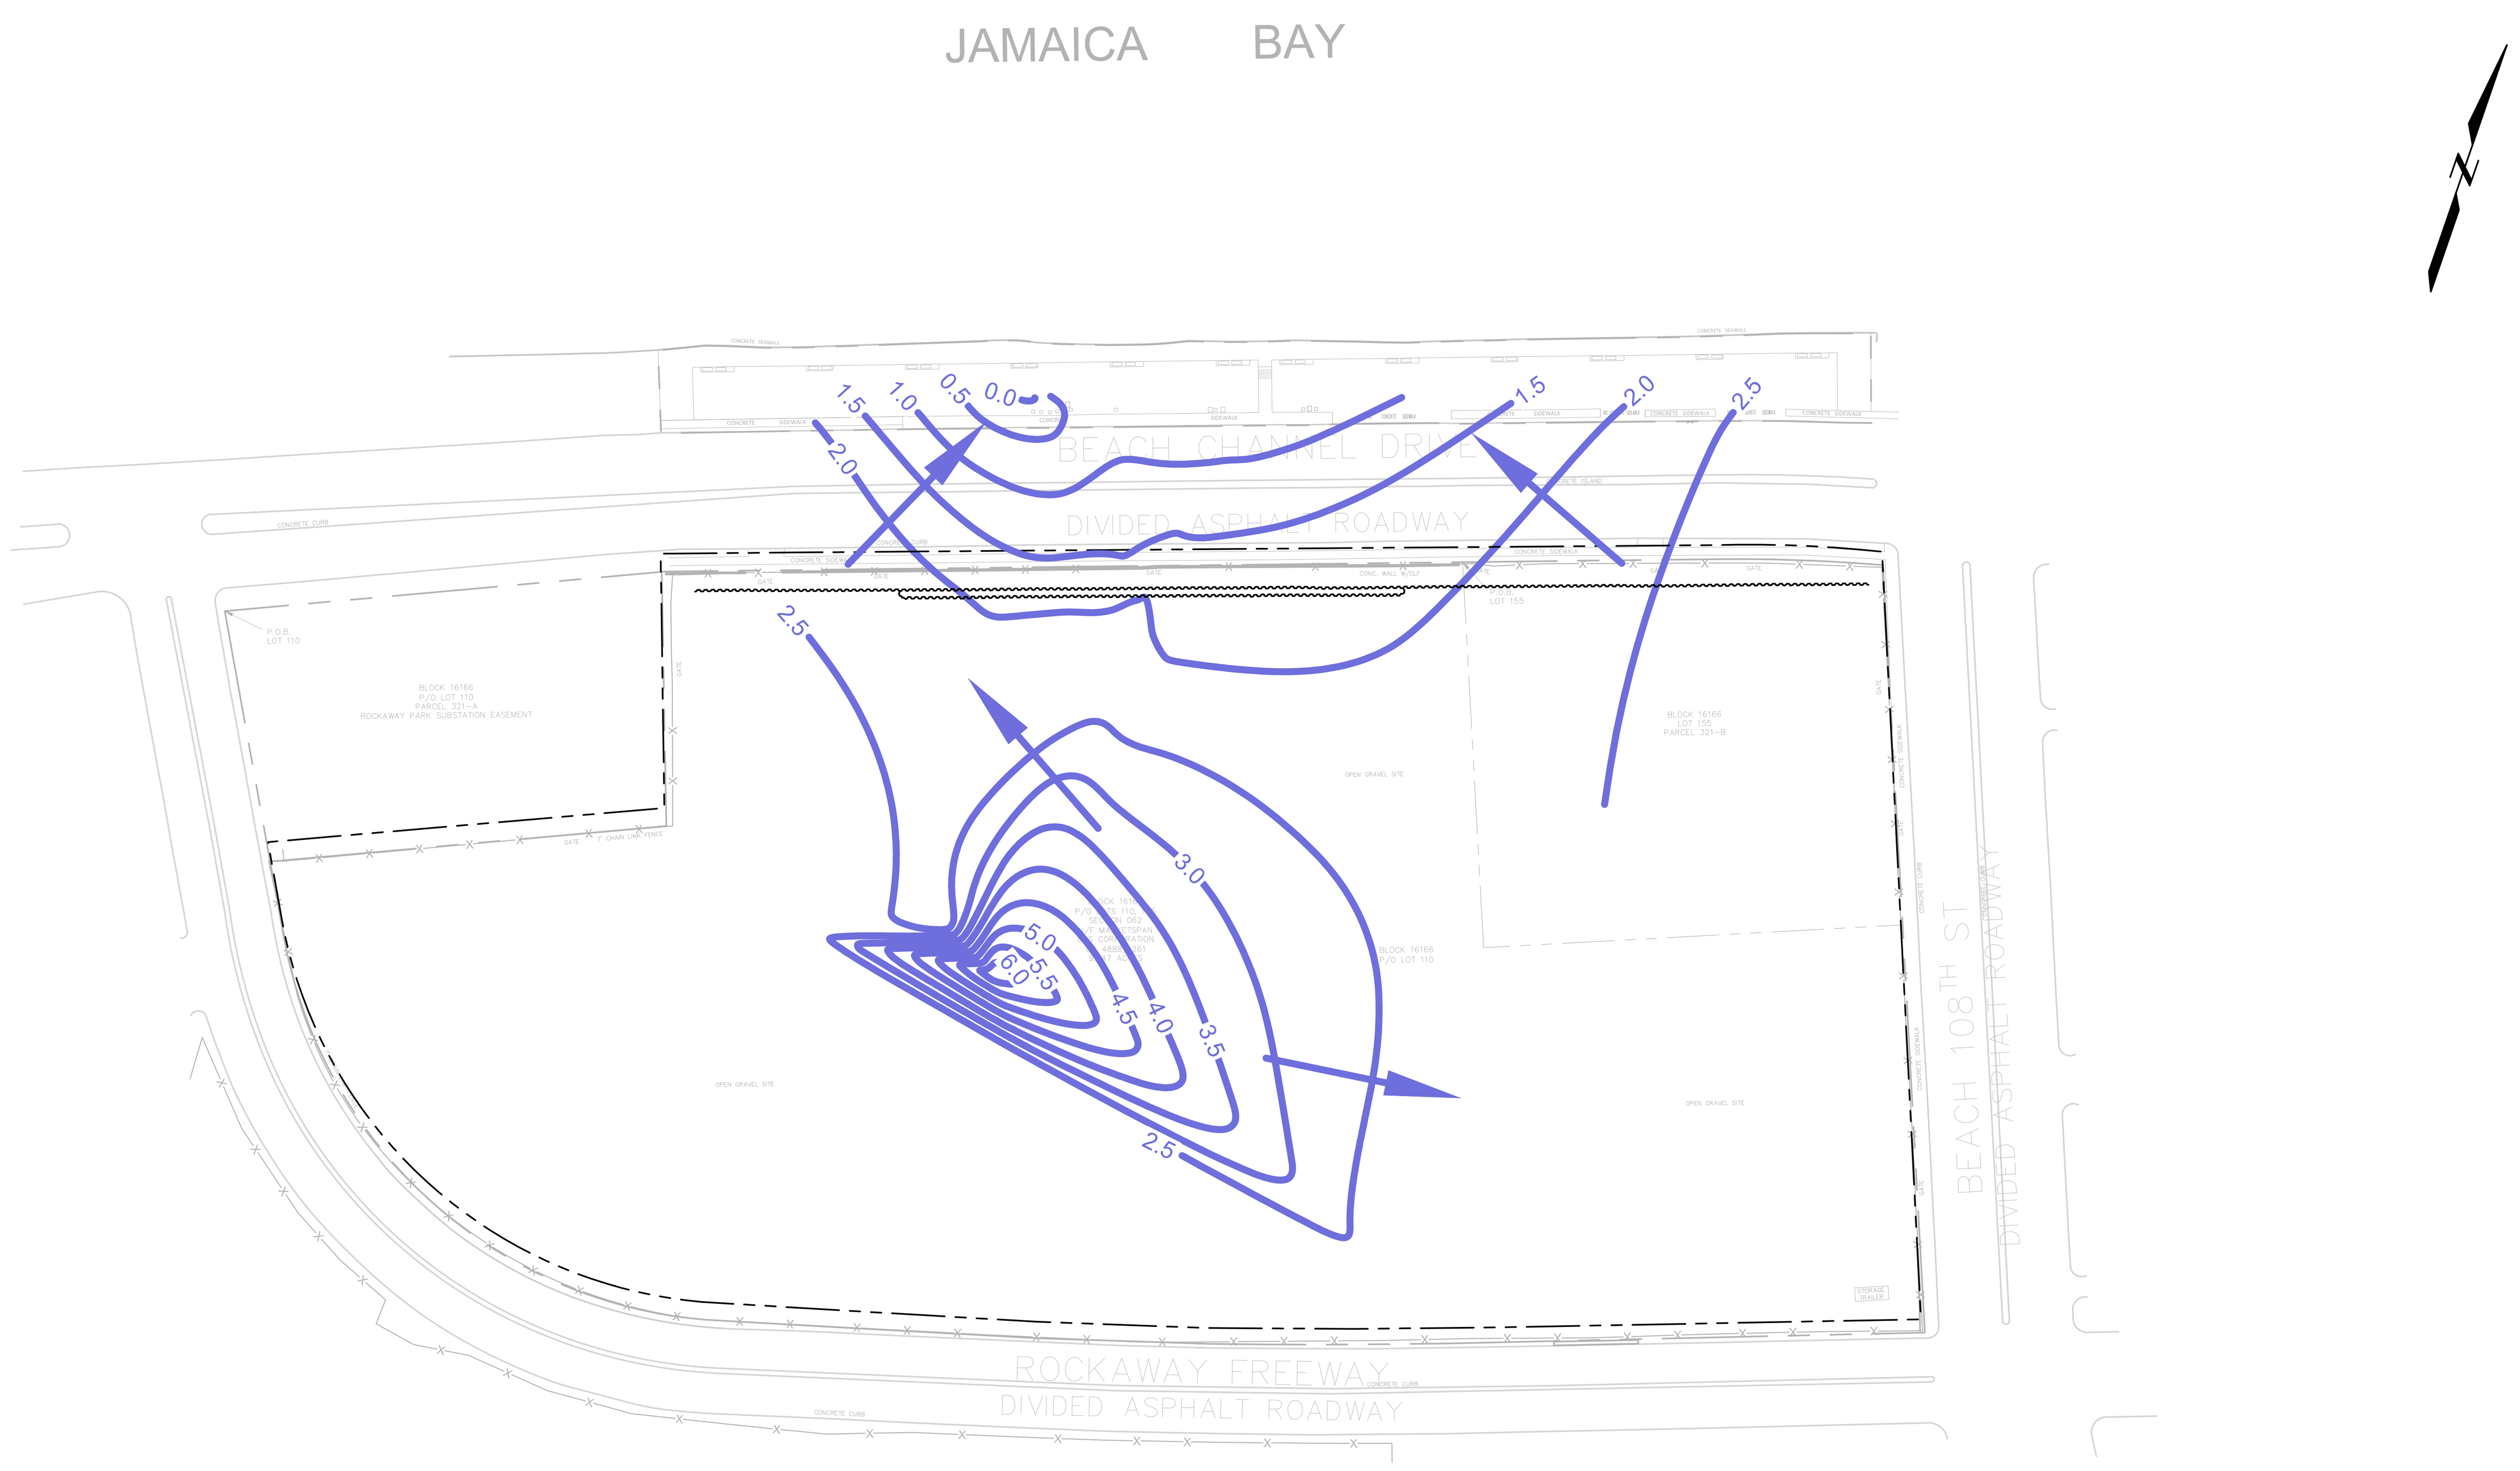
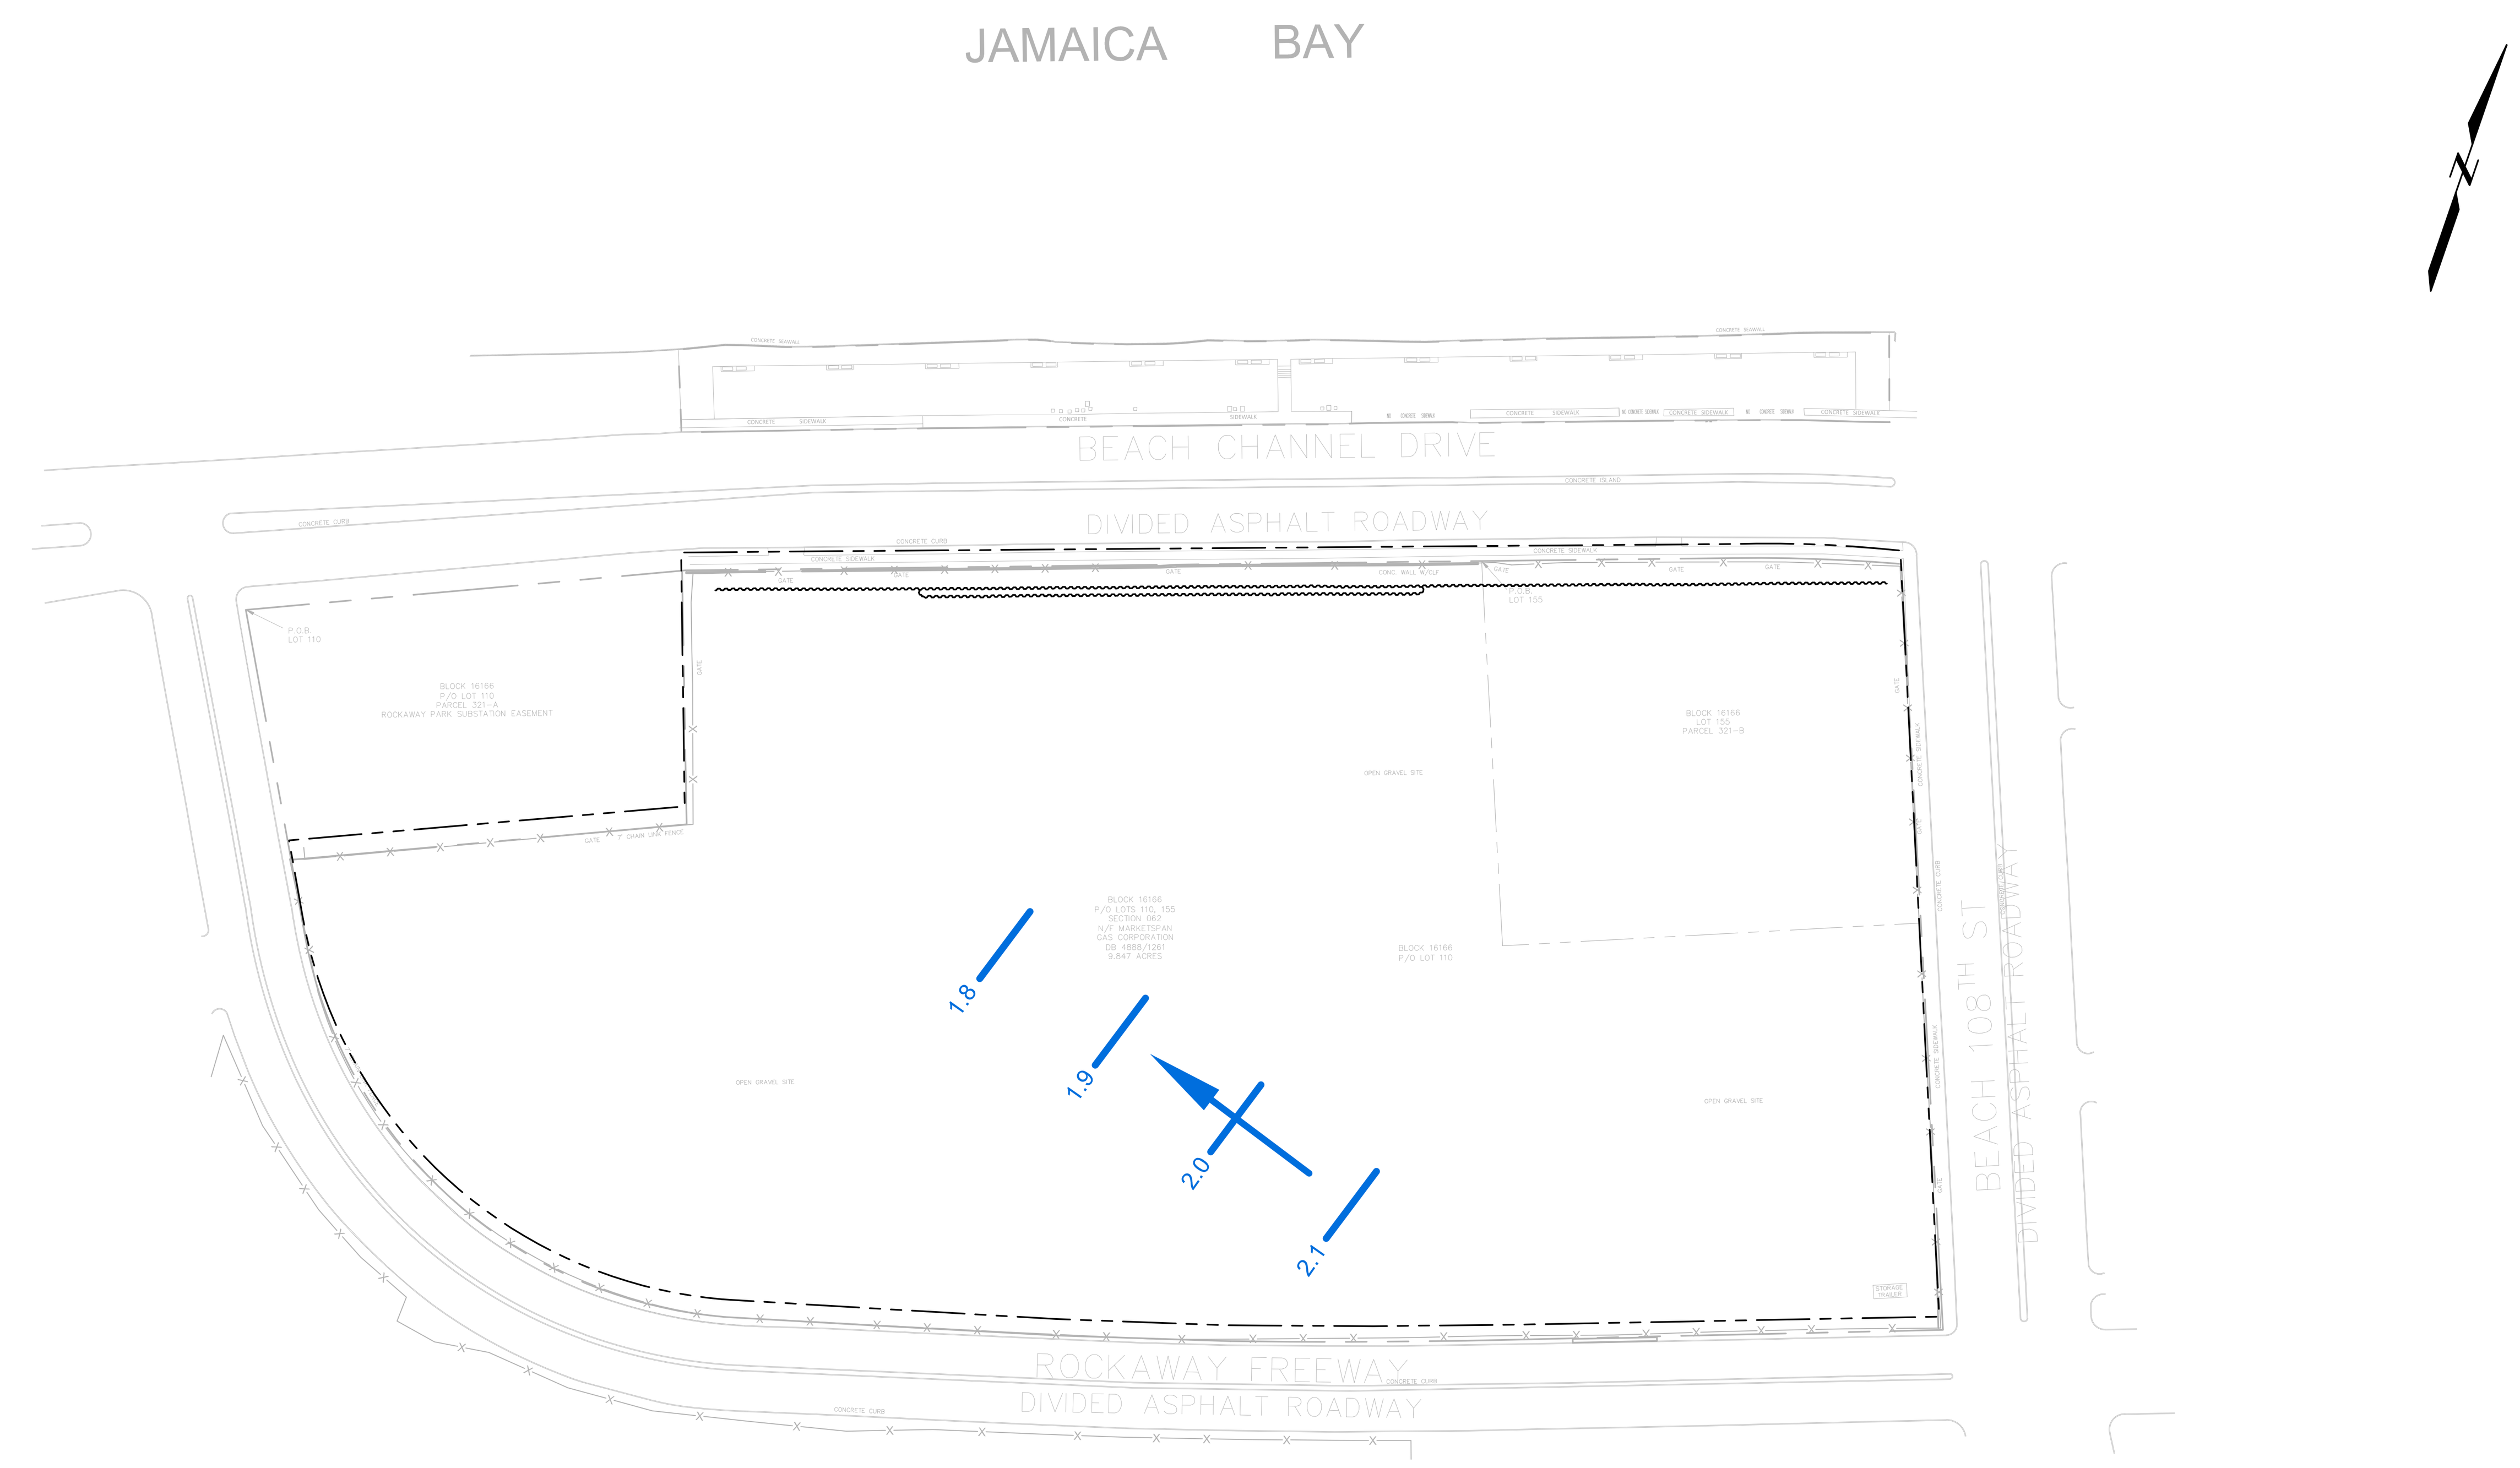
Project 093150 | February 2020 | Fig. 4

SHALLOW HIGH TIDE
(SCREENED INTERVAL: 2 - 17 ft bgs)

INTERMEDIATE HIGH TIDE
(SCREENED INTERVAL: 17 - 45 ft bgs)

DEEP HIGH TIDE
(SCREENED INTERVAL: 45 - 90 ft bgs)

DEEP 2 HIGH TIDE
(SCREENED INTERVAL: 90 - 105 ft bgs)

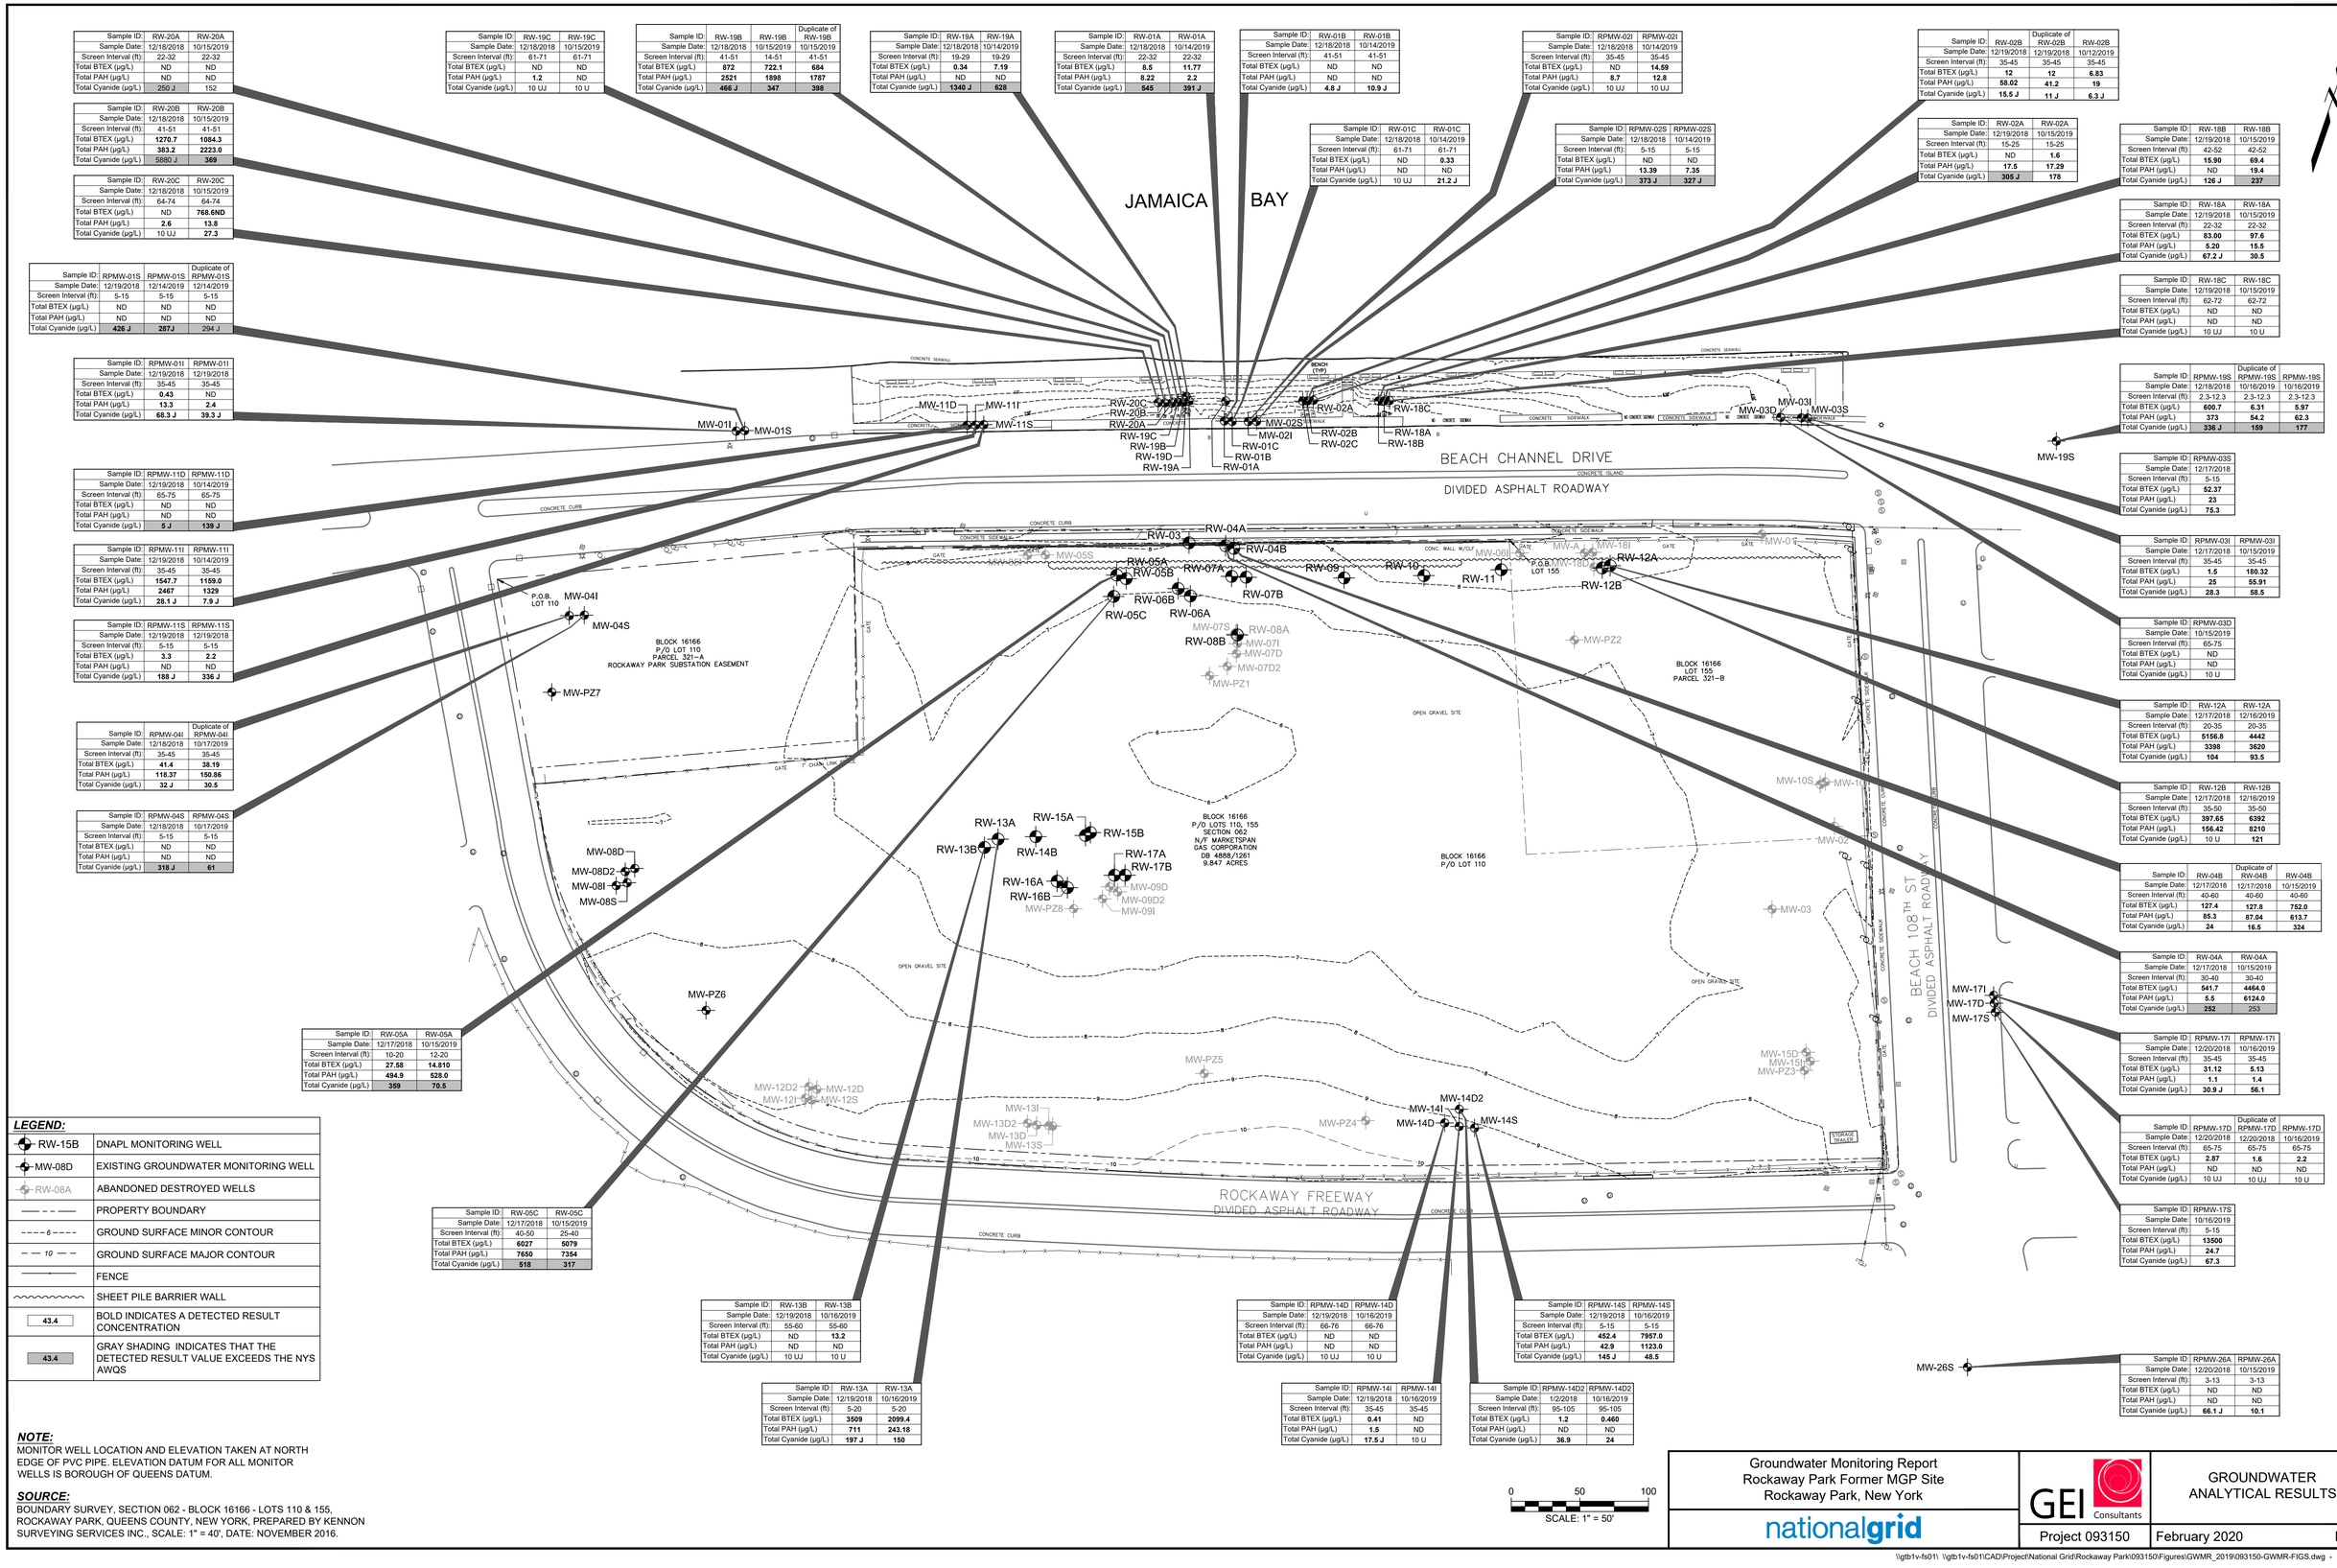
Sample ID:	RW-20A	RW-20A
Sample Date:	12/18/2018	10/15/2019
Screen Interval (ft):	22-32	22-32
Total BTEX (µg/L)	ND	ND
Total PAH (µg/L)	ND	ND
Total Cyanide (µg/L)	250 J	152

Sample ID:	RW-20B	RW-20B
Sample Date:	12/18/2018	10/15/2019
Screen Interval (ft):	41-51	41-51
Total BTEX (µg/L)	**1270.7**	**1084.3**
Total PAH (µg/L)	**383.2**	**2223.0**
Total Cyanide (µg/L)	5880 J	**369**
